# Sample Report — South Elevation

Created by Fasadogled · Date: 17 Aug 2026 · Defects: 3 · Photos: 3

This is a sample Fasadogled report, produced from an illustrative building rather than a real survey. Visual condition inspection of the south elevation, carried out by rope access. Three defects recorded; close-up photography by the access team on site.

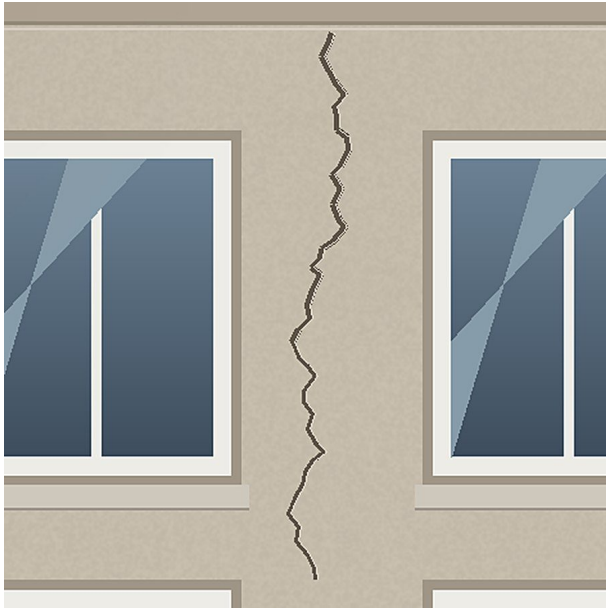
### #1 Vertical crack below cornice

Crack approximately 1.4 m long running from the cornice joint, 2–4 mm wide, widening towards the top. Render sounds hollow either side. Water ingress likely.

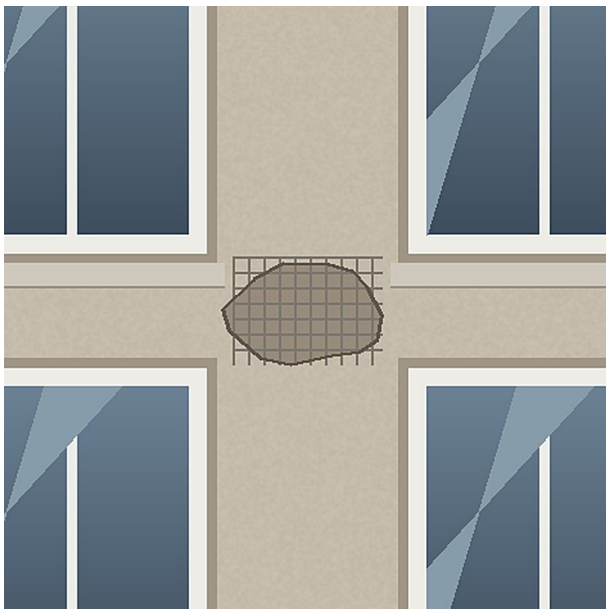
## #2 Spalled render, exposed mesh

Render detached over roughly 0.35 m<sup>2</sup>, reinforcement mesh exposed and beginning to corrode. Edges friable — remove back to sound material before patching.

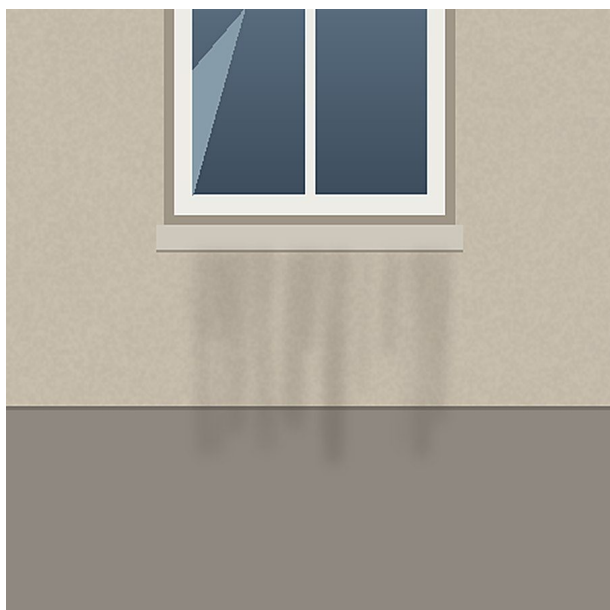
## #3 Water staining below sill

Persistent staining over about 1.8 m of wall beneath a failed sill drip. Sealant perished along the full reveal; re-form the drip and reseal.
